Here is your report on the investigation of the semi-face clay bricks (FBA) which we received on the 15 April 2021. This work was carried out as requested and has been allocated Cermalab project number C21-030 C.

## **TEST REPORT**

## **INVESTIGATION OF CLAY BRICKS FROM OCON BRICKS**

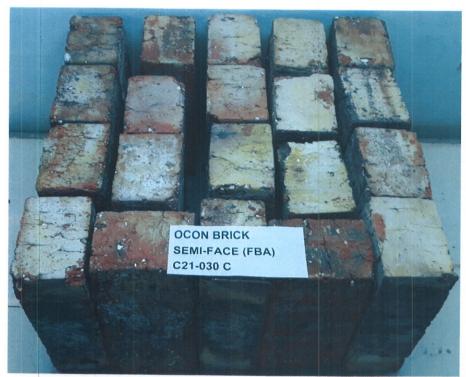
Sample name	Number of units that exhibit efflorescence  Degrees of efflorescence					
	Nil	Slight	Moderate	Heavy	Serious	Pass/Fail
Ocon Semi- face	8	12	0	0	0	Pass
SANS Standard		10	10

Figure 3.5.1: Samples after efflorescence testing

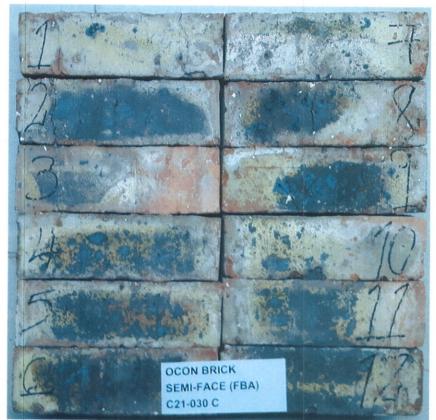
Figure 3.7.1: Samples as received and numbered for reference on CCS
